**MARINE BORERS AND THEIR RELATION TO
MARINE CONSTRUCTION ON THE
PACIFIC COAST**

**FINAL REPORT
OF THE
SAN FRANCISCO BAY MARINE PILING COMMITTEE**

C. L. Hill and C. A. Korom
Editors-in-Chief

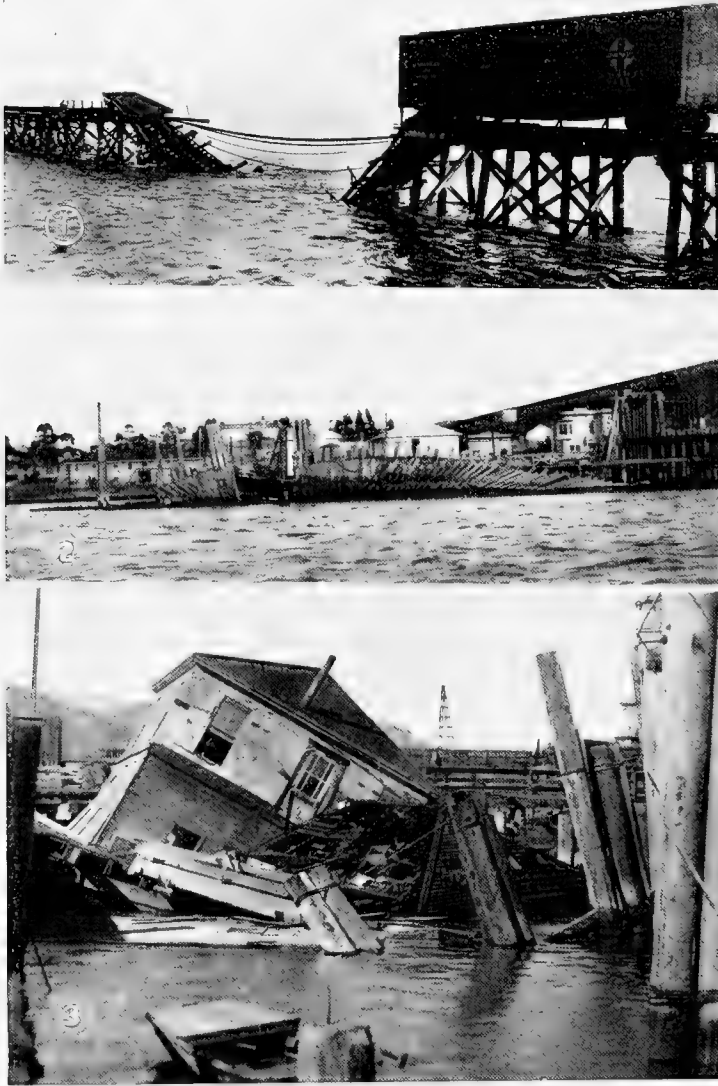
Fig. 1. Dock failures in Carquinez Strait.

- (1) One of the first docks which failed. Oleum, California, Oct. 8th, 1919. Several loaded freight cars were plunged into the bay.
- (2) Ferry slip at South Vallejo, failed November 4th, 1920.
- (3) Municipal Wharf and house, Benicia, California. Collapsed Oct. 7th, 1920.

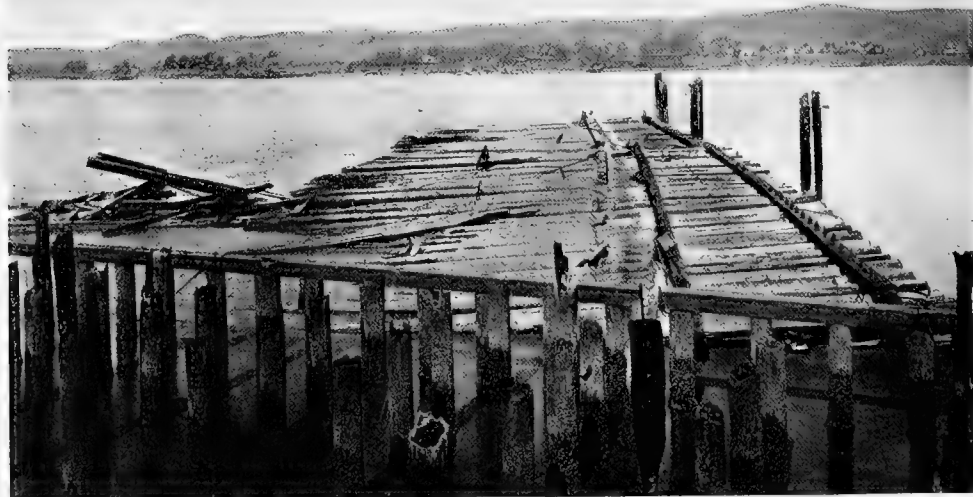
Fig. 12. Untreated ferry slip fender piles in Carquinez Strait destroyed by teredo, 1919.
(S. P. Co. Photo.)

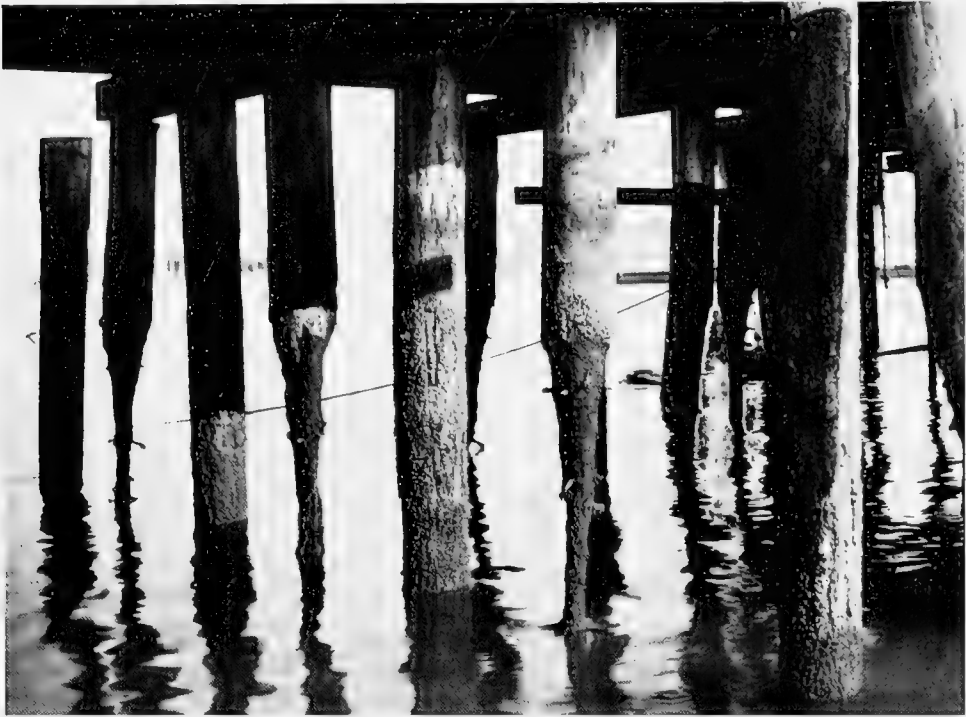
Fig. 13. Untreated Douglas fir piling in Oakland Estuary, destroyed by *Limnoria*. Good piles shown are replacements. (Moore Shipbuilding Co. Photo.)

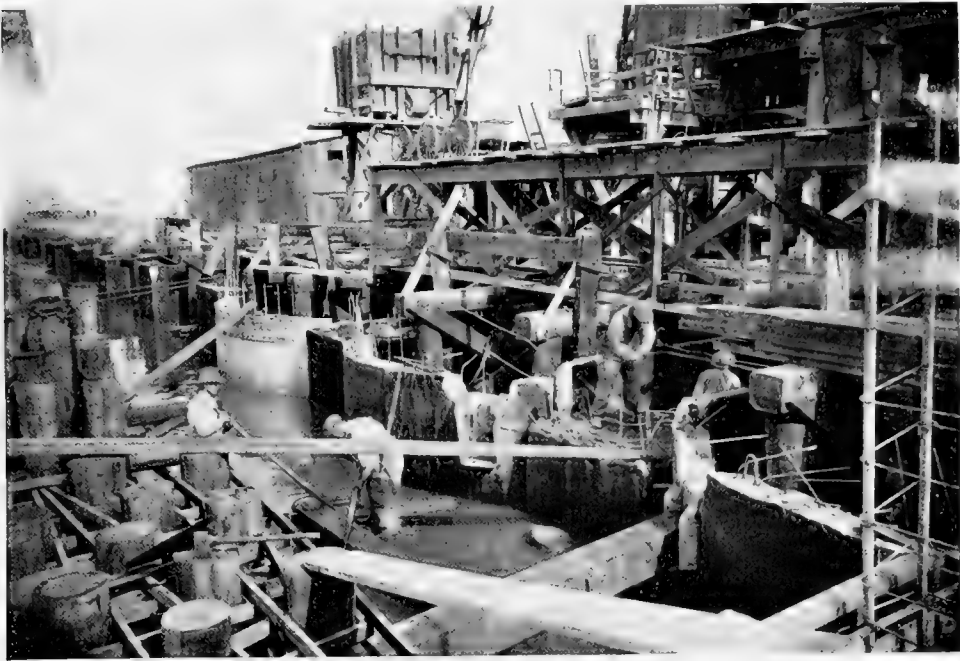
Fig. 15. China Basin terminal during construction, showing caissons after filling (workman whose hands are blurred is standing in one) and pre-cast curved arch slabs in place.
(Board of State Harbor Coms. Photo.)

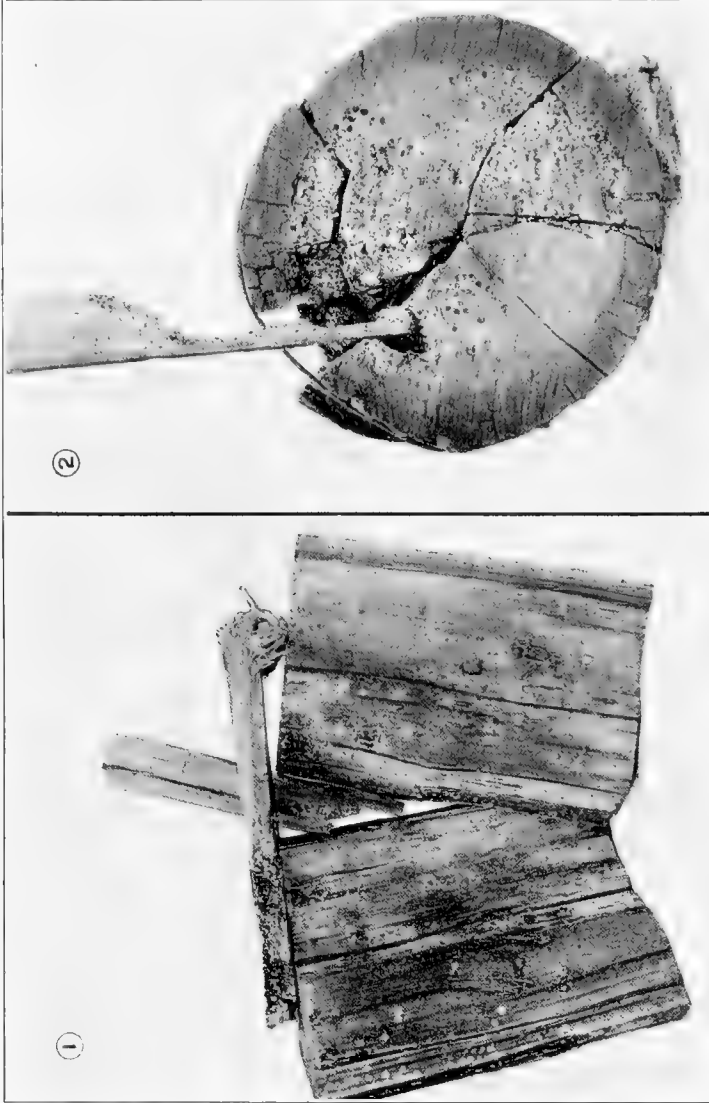
Fig. 25. (1) Vertical section, and (2) cross-section through portion of a perfectly treated pile which was split and broomed during driving. *Ixodes* entered splits and worked through untreated heartwood to the creosoted outer shell, which was attacked in a few spots as shown by smaller pieces.

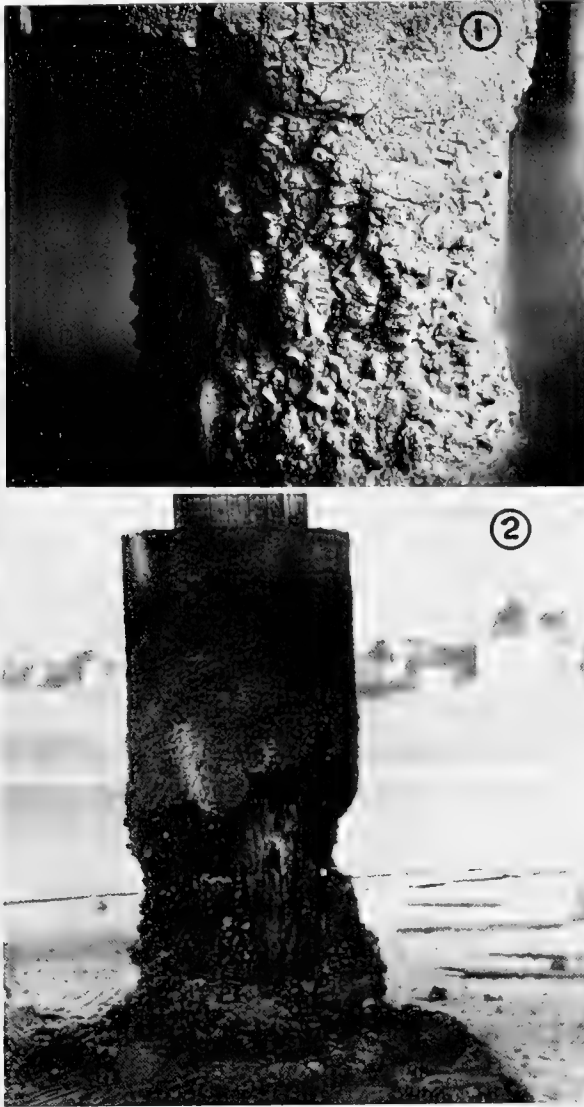
Fig. 29. (1) Disintegration in concrete composite pile. Probably a result of poor workmanship.
 (2) Disintegration in concrete jacket placed on pile previously covered by battens and paint. Pile attacked by *Limnoria* where coverings have failed.

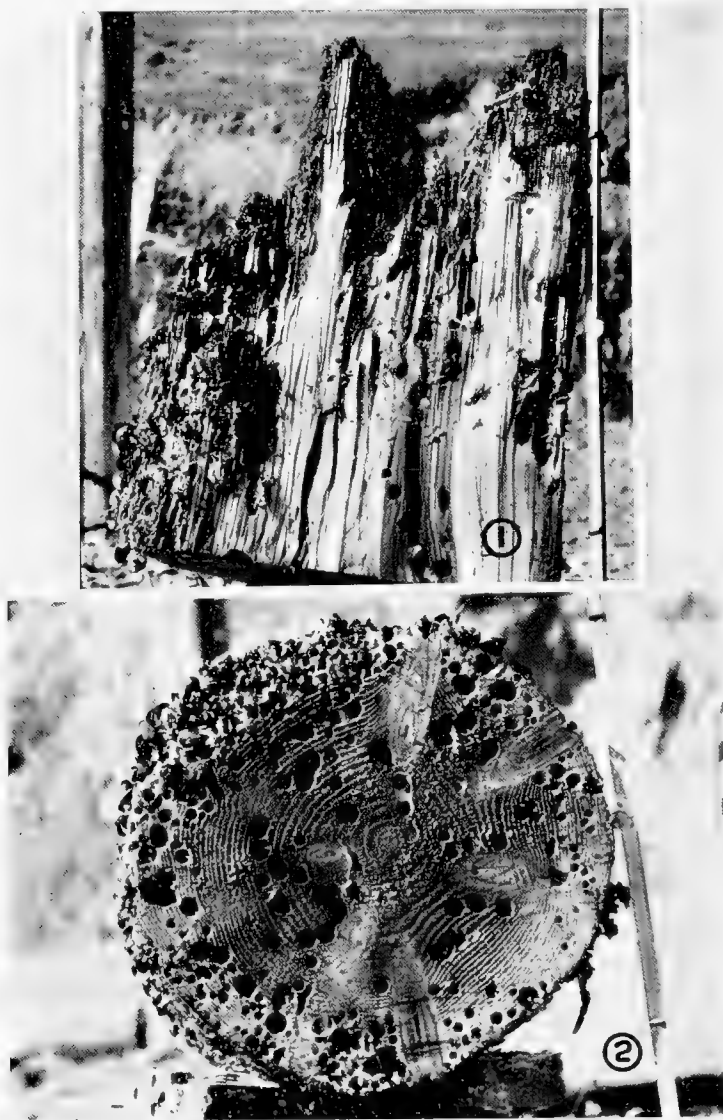
Fig. 32. (1) Dolphin pile from Richmond Municipal Pier, driven December, 1917, broken out July, 1920. Note large tubes of *Bankia* and smaller ones of *Teredo navalis*, and erosion by *Limnoria* at breaking level. *Sphaeroma* also present. Breaking zone exposed at low tide.
(2) Section of same pile, one foot above break.

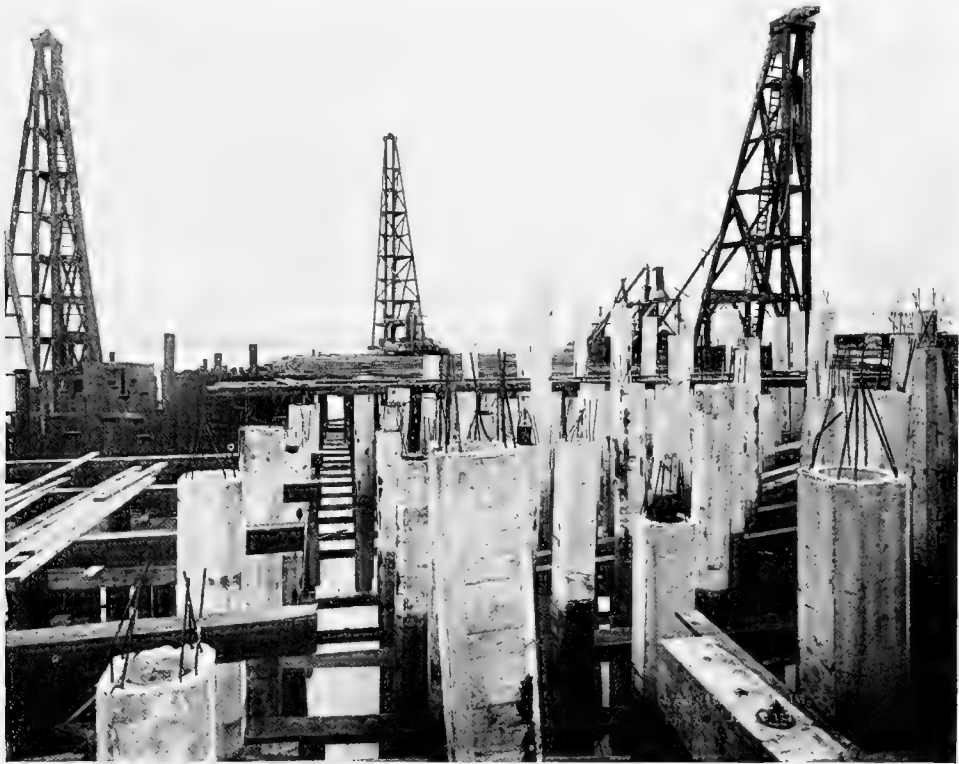
Fig. 47. Pre-cast concrete jackets in place over piles. Alaska Packers' Assn., Alameda.

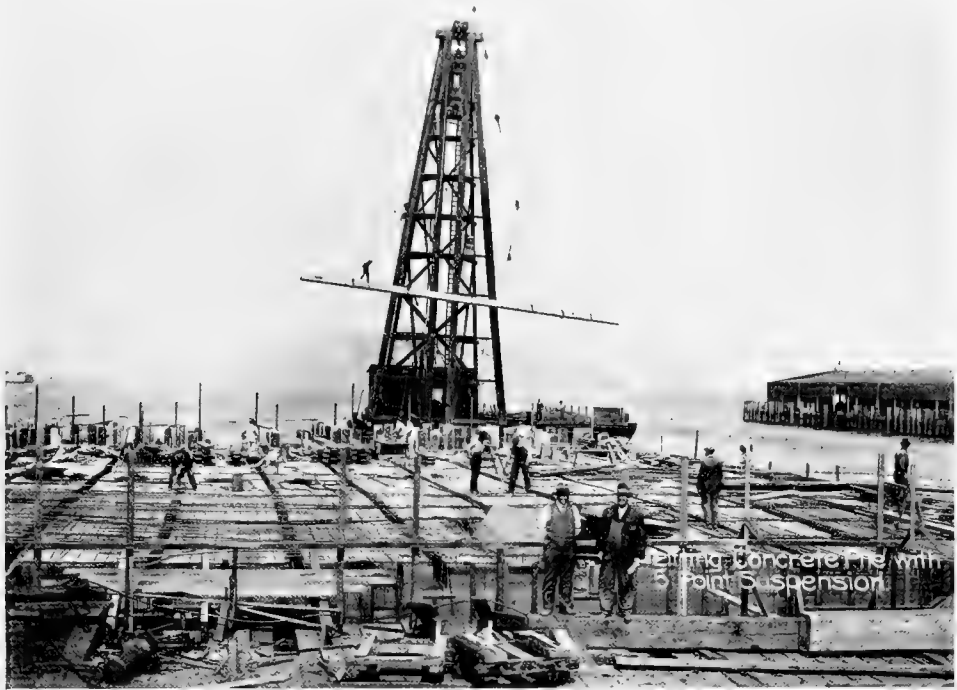
Fig. 51. Handling 105-foot concrete pile with 5-point suspension, Pier 3, San Francisco.
(Board of State Harbor Com's. Photo.)

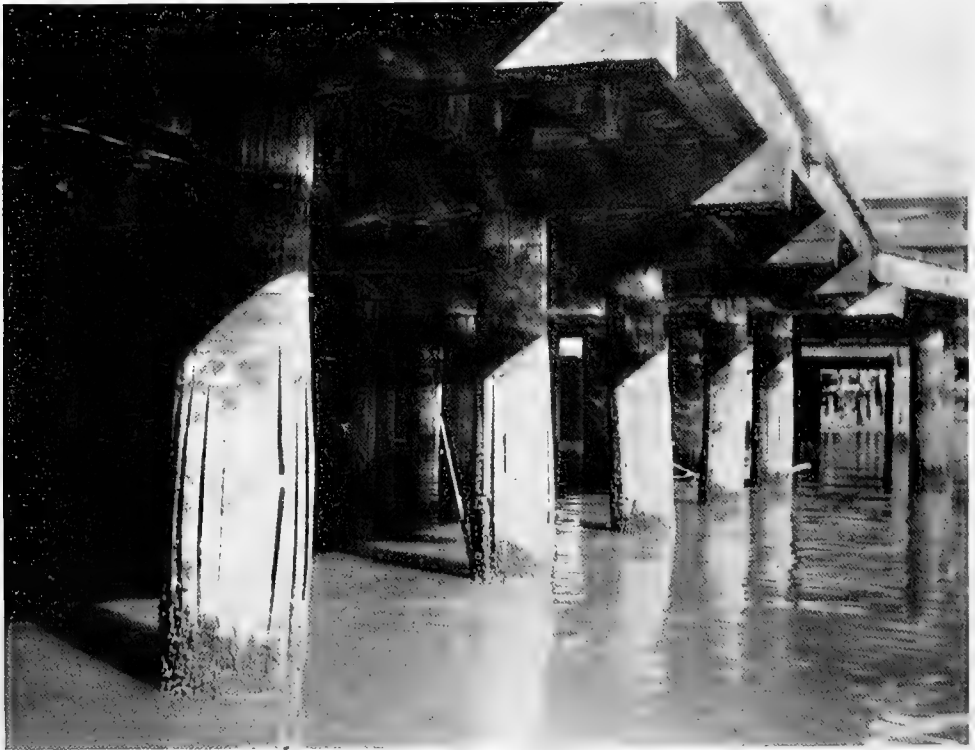
Fig. 56. Piling treated by Moran process, exposed 2 years at Georgia St. Wharf, Vallejo. Note bulging and broken battens. (S. P. Co. Photo.)

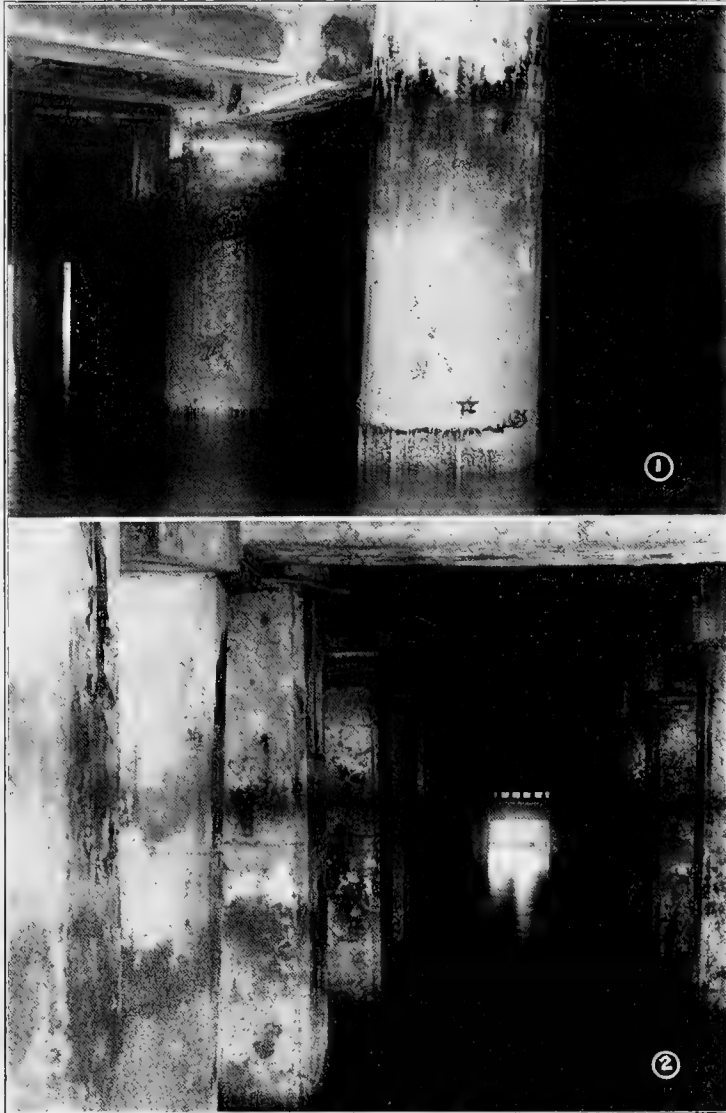
Fig. 59. (1) Reinforced concrete cylinders, Pier 28, San Francisco. Disintegration of concrete due to poor workmanship and improper tamping. These cylinders were repaired by encasing in dense concrete.
(2) Reinforced concrete piles, Pier 35, San Francisco; 6 years exposure, excellent condition.

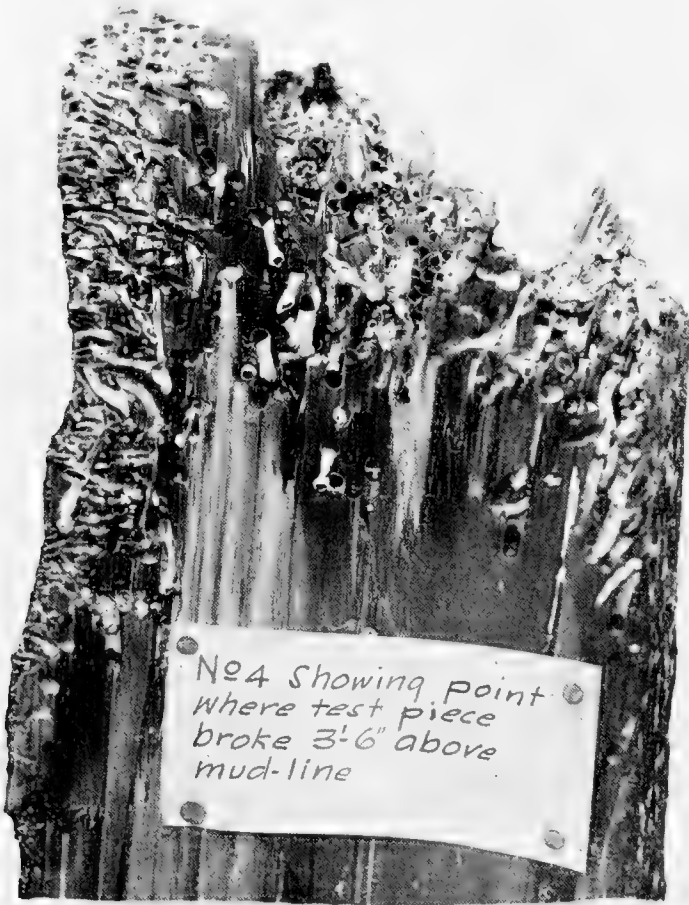
Fig. 87. Breaking point of a 6 x 8 Douglas fir timber planted at Southern Pacific wharf, Port Costa, California, July 1, 1920. First larvae detected at this locality on August 4. Timber removed December 8, 1920. Destroyed by *Teredo nautilus*.

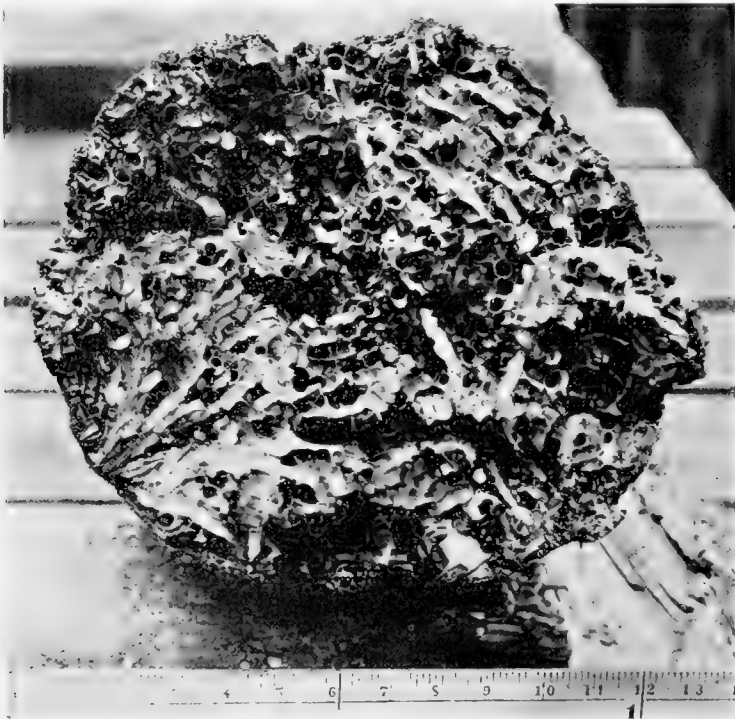
Fig. 89. Breaking point, near mud line, of pile at Oakland Mole, destroyed within 5 months by *Bankia setacea*.

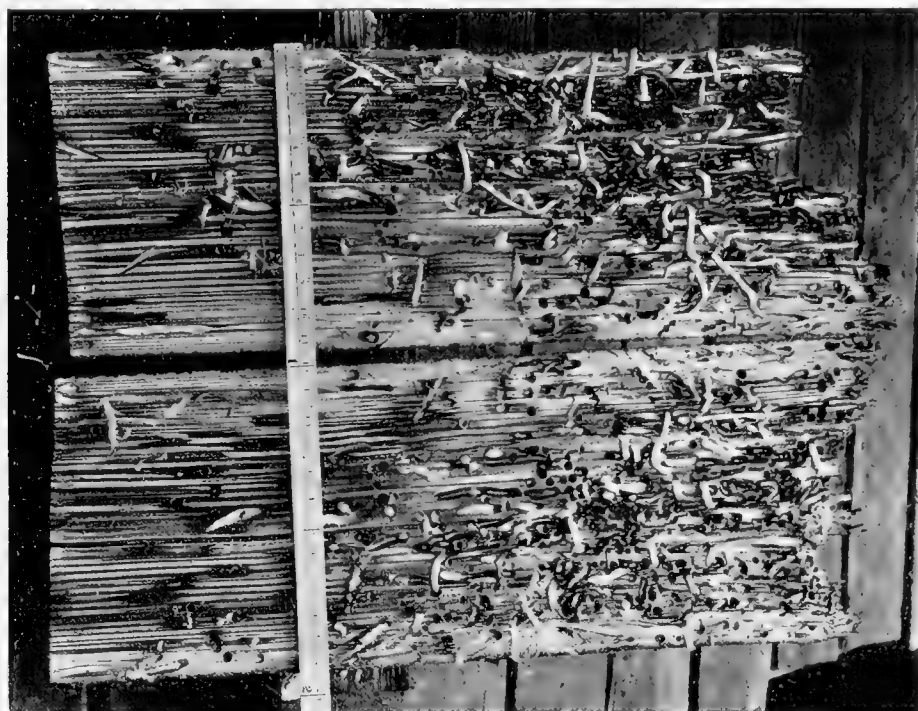
Fig. 90. Split section of pile shown in fig. 89.

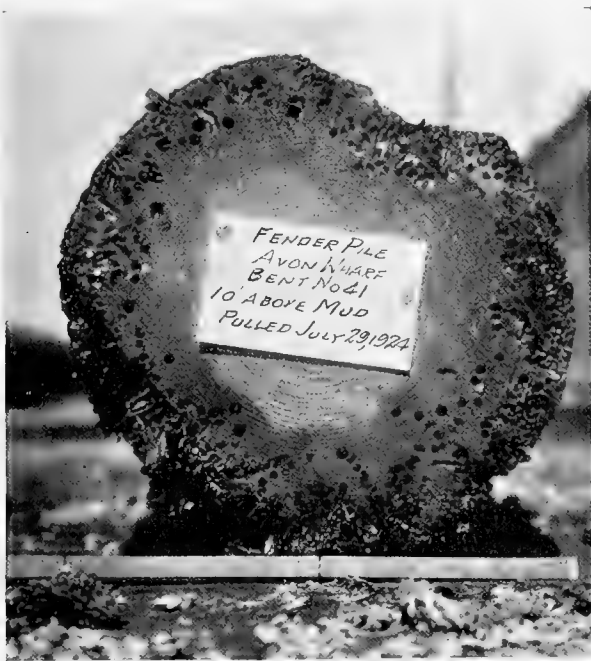
Fig. 96. Section of untreated fender pile from Avon wharf of Associated Oil Co. Pulled July 29, 1924.

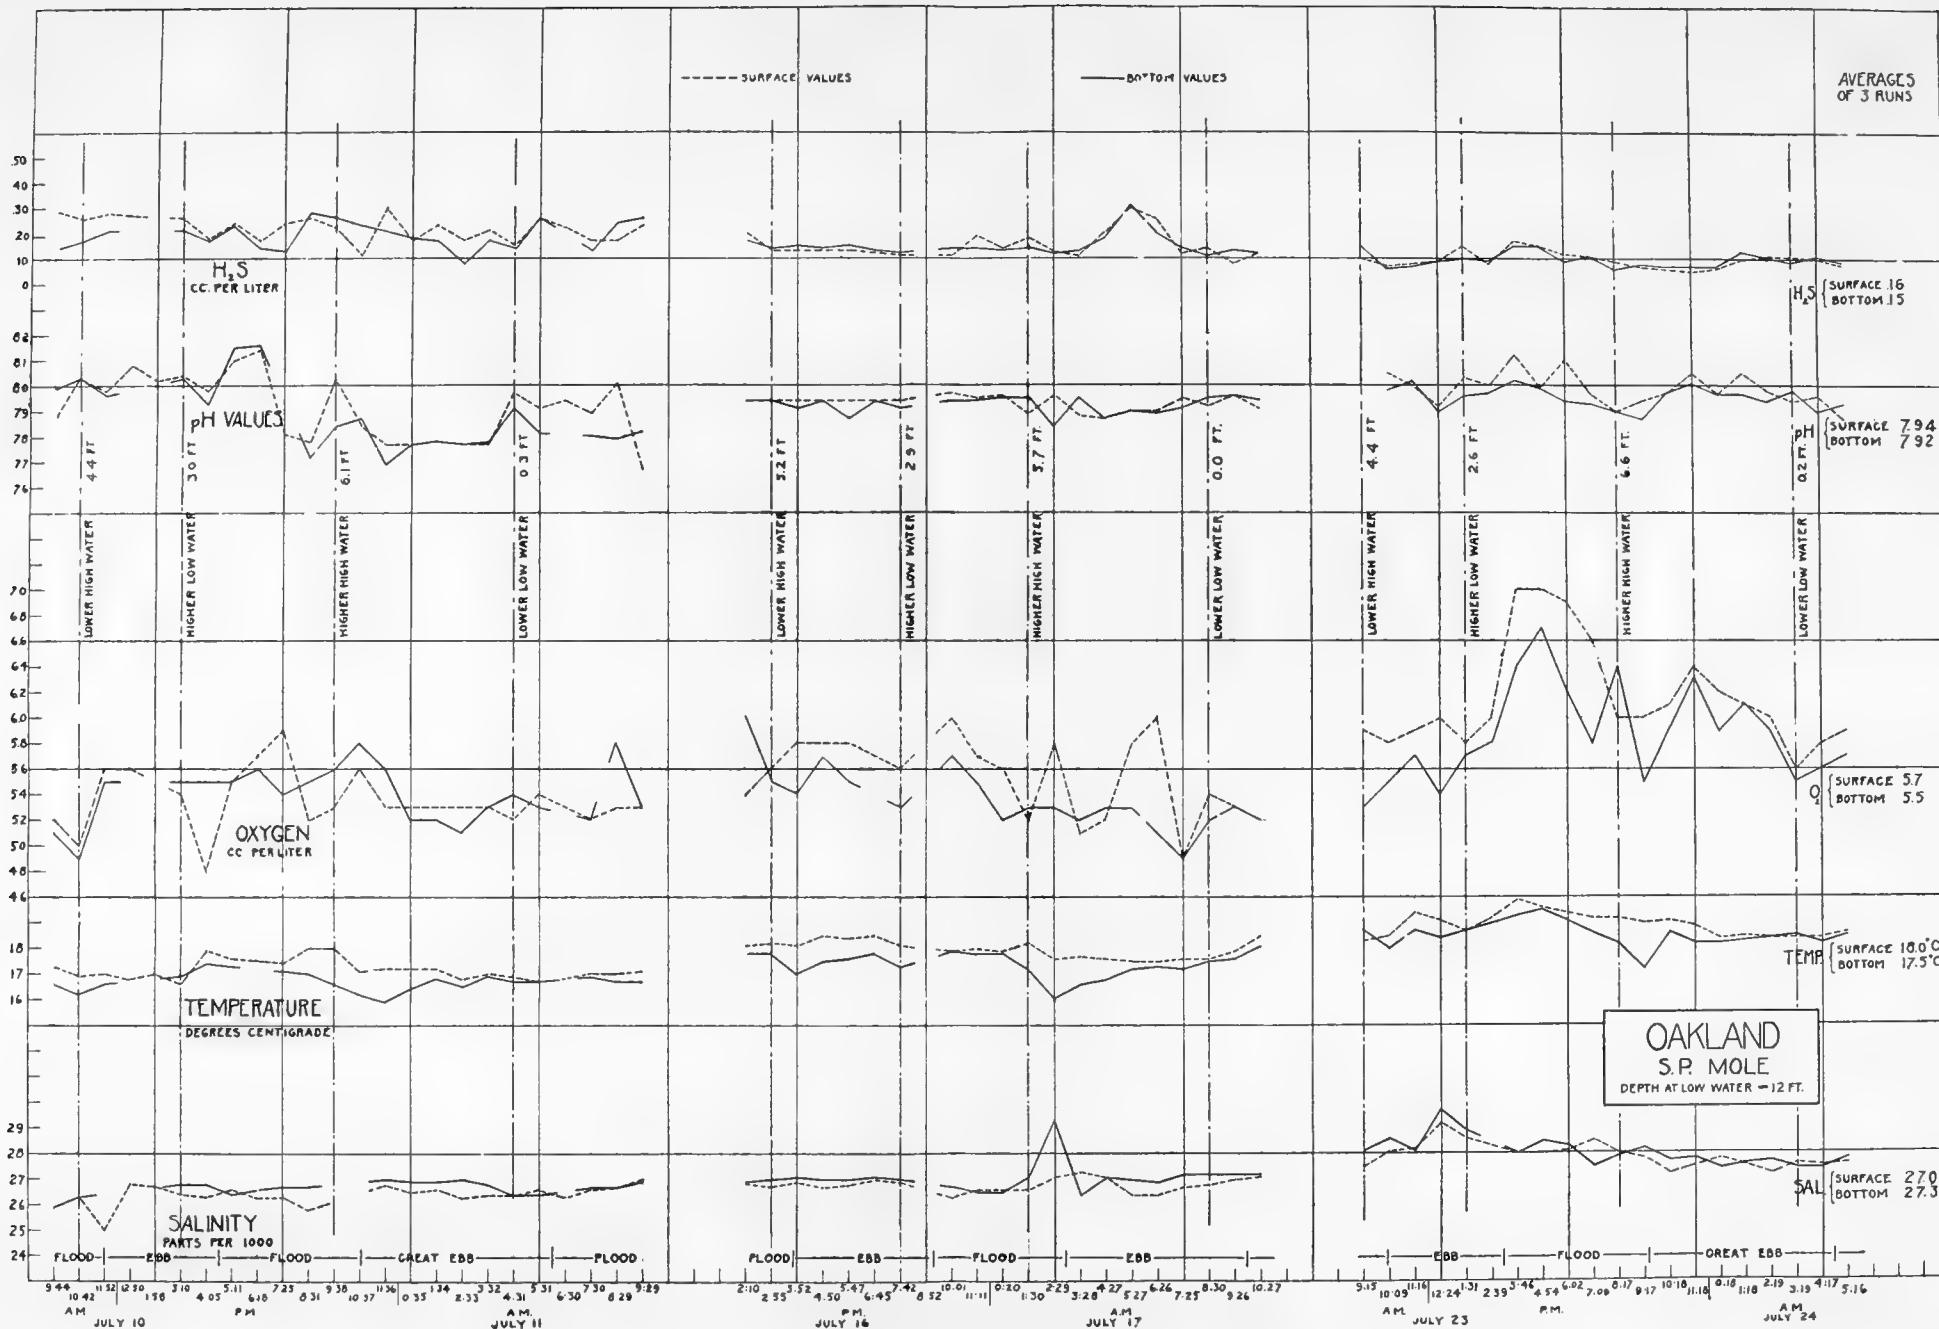
Fig. 103. Graphs of physical and chemical conditions in San Francisco Bay, at the Oakland Mole, in July, 1923.

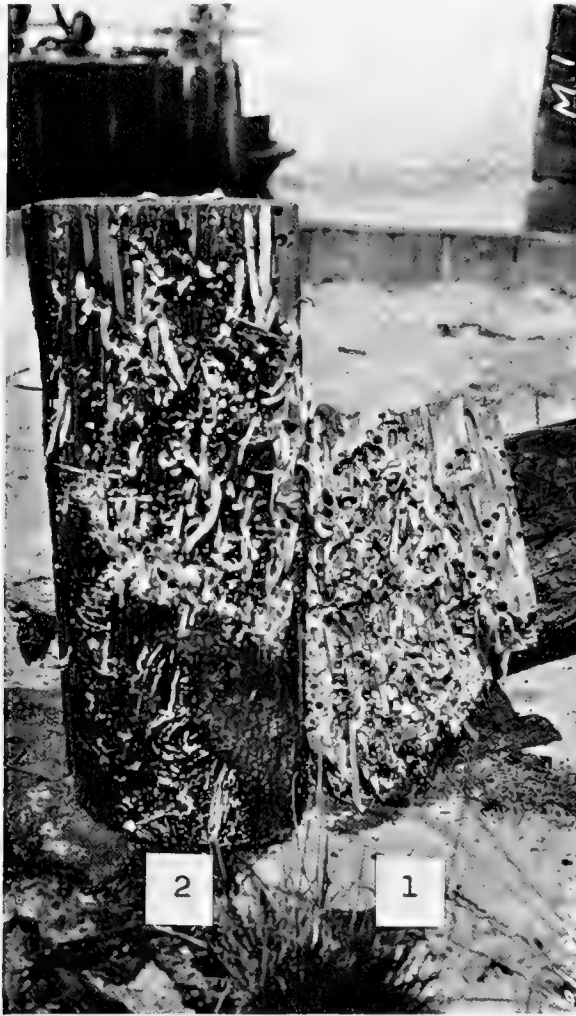
Fig. 116. Pile from Seattle, driven December, 1922, pulled June, 1924. Entirely destroyed at mud line by *Bankia setacea*.

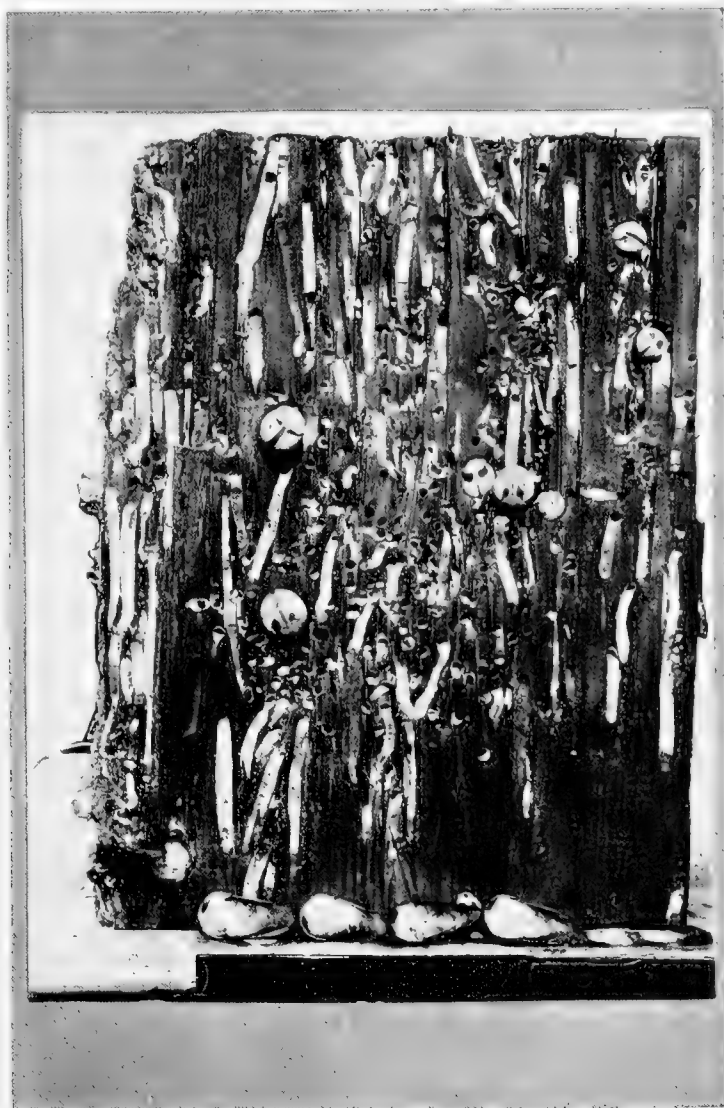
Fig. 119. Sample of 12" x 12" timber submerged 10 months in Pearl Harbor. Split surface showing damage by *Teredo parksi* and *Martesía striata*, the latter organisms still in place in burrows.
(Photo by courtesy of Public Works Dept., U. S. Naval Station, Hawaii.)
